Deep Space Network Control Room Noise and Vibration Study

J. C. Rayburn
Deep Space Network Support Section

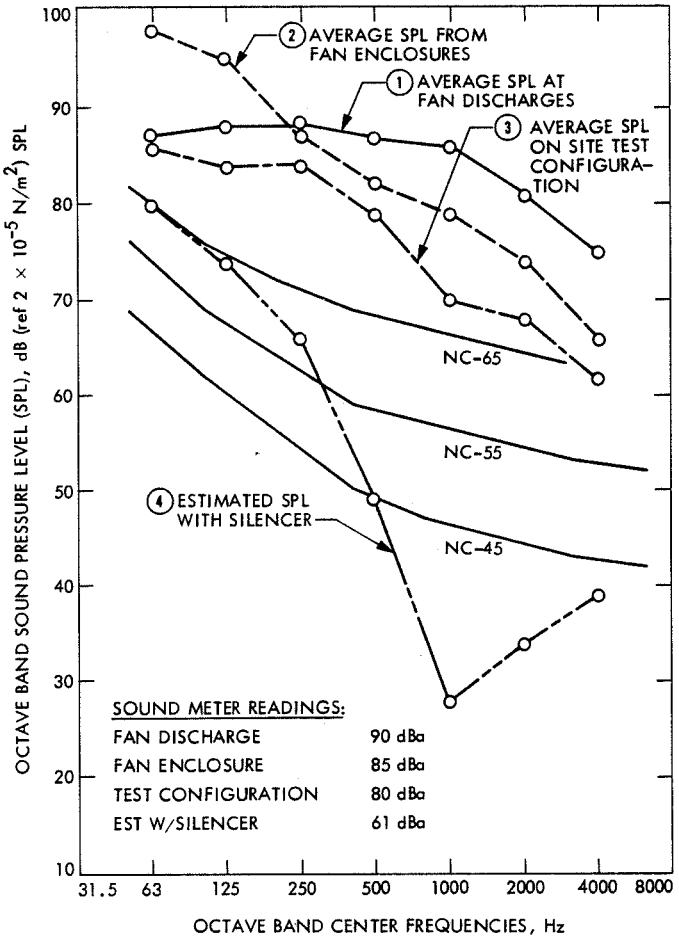
Fig. 1. Fan noise levels in plenum

Figure 1, Curve No. 1, shows the range of noise (sound pressure levels), measured one meter from the discharge of

three Westinghouse draw-through-type Air Handling Units (AHU-2, AHU-3, and AHU-4) located in the plenum at DSS 61/63. Two of the three units, AHU-2 and AHU-3, operate continuously. Presently, AHU-4 is not used (except during adverse conditions when maximum cooling is required) because of its location directly beneath the Station Monitor and Control area. Figure 1, Curve No. 2, shows the range of noise levels radiated from the three fan enclosures. Figure 2 compared dBa sound meter readings in the Station Monitor and Control area of the Operations Room with AHU-3 and AHU-4 operating together and with AHU-2 and AHU-4 operating together. The difference in sound level measurements ranged between 2 and 7 dBa at various operator positions.

As an on-site experiment, AHU-2 fan noise was considerably reduced when an experimental plywood duct lined with 25-mm, semirigid glass fiberboard was placed in front of the air handler output. The noise reduction achieved by this experiment (10 dBa sound meter reading) is compared with existing conditions in Fig. 1, Curve No. 3.

The estimated values of noise reduction at the AHU-3 duct output (29-dBa sound meter reading) for these improvements are shown on Fig. 1, Curve No. 4.

Analysis of the measured data, coupled with on-site noise reduction tests, indicated that prefabricated sound attenuators or silencers in conjunction with duct work lined with a glass-fiber duct liner attached at the fan discharge should be installed on the three air handlers located in the Operations Room plenum at DSS 61/63.

Because of the air distribution and total volume requirements, silencers with low static pressure drops are required. It is estimated that the static pressure drop for each AHU, due to silencers only, will be about 5 mm to 8 mm for a 1-m-long silencer. The existing AHUs' capacities can compensate for these static pressure drops.

A design concept developed jointly by DSN support and station personnel for implementing the plenum air handler noise and vibration suppression technique described in Section IV was detailed. Requests for implementation bids have been solicited from local Spanish heating and venting contractors. It is expected the modifications will be completed during the second quarter of FY 80.

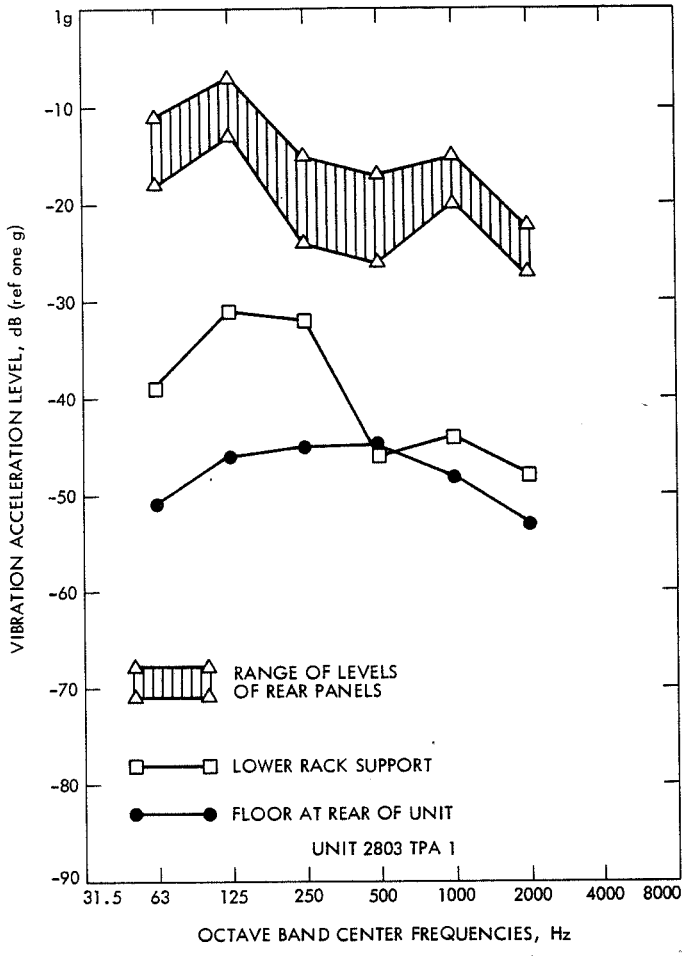
Fig. 3. Vibration levels at Wangco Magnetic Tape Recorder

Figure 3 compares vibration measurements of upper and lower Wangco Tape Recorders at DSS 61/63. These units are supported only at the front of the cabinet with the entire casing cantilevered. All measurements were made in the middle of the rear panels where vibration acceleration levels were greatest.

Consideration will be given to mounting a horizontal angle support spanning the entire cabinet width near the rear of the unit. This will provide significant additional stiffness to these recorders and reduce the vibration levels associated with these units.

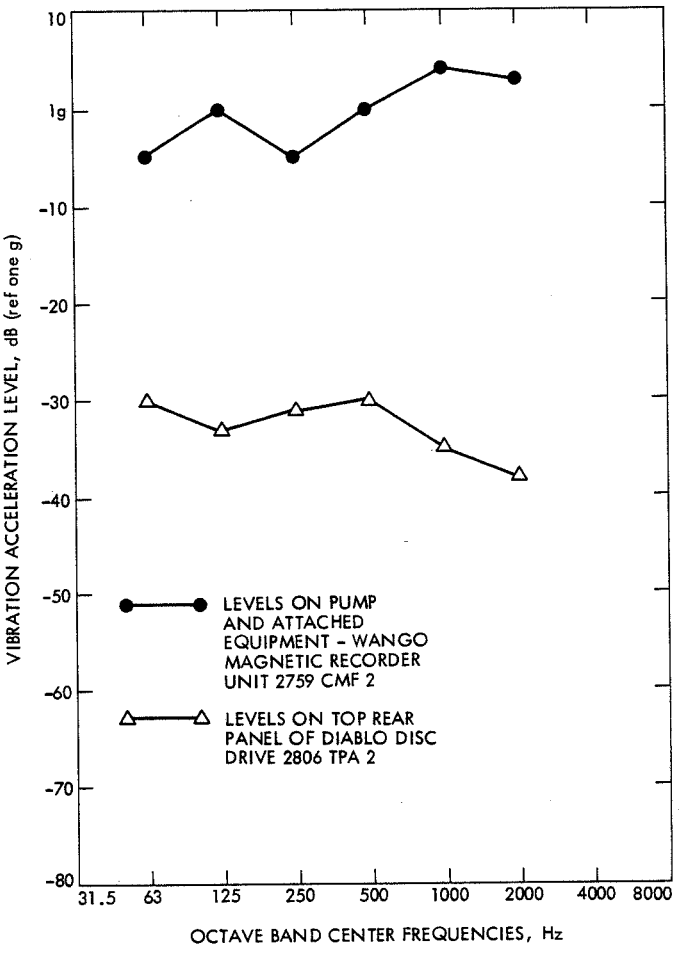
Fig. 4. Vibration levels at vacuum pump/Diablo Disk Unit

For the Diablo Disk Units, measurements for vibration were made at the rear of the horizontal sliding support tracks. Figure 4 shows the levels measured for the Diablo Disk Drive Unit at the top rear panel.

Figure 4 also displays the average vibration levels measured on the Wangco vacuum pump housing and its integrally attached hardware at DSS 61/63. This entire unit is supported by three rubber mounts at the rear of the cabinet. This allows the cantilevered front left corner to be relatively free to move and is the location where the measurements were made.

All rack supports and associated connections will be stiffened. All tracks will be aligned vertically and any horizontal adjustments will be made at the cabinet mounts to ensure proper tolerance between tracks. Connections and mounting hardware joining the tracks to the angles which support the Diablo Disk Unit are to be made as tight as possible.

Attaching horizontal angle supports to the existing front metal flange, just above the fan, and an anchor to each cabinet sidewall should provide maximum vibration reduction for the vacuum pump. Alternately, adding a support similar to the existing hard rubber mounts between the cantilevered front left corner of the pump and the cabinet sidewall would reduce vibration.
